Aviation Investigation Final Report

Location:	Monterey, California	Accident Number:	WPR21FA270
Date & Time:	July 13, 2021, 10:42 Local	Registration:	N678SW
Aircraft:	Cessna 421C	Aircraft Damage:	Destroyed
Defining Event:	Collision with terr/obj (non-CFIT)	Injuries:	2 Fatal
Flight Conducted Under:	Part 91: General aviation - Personal

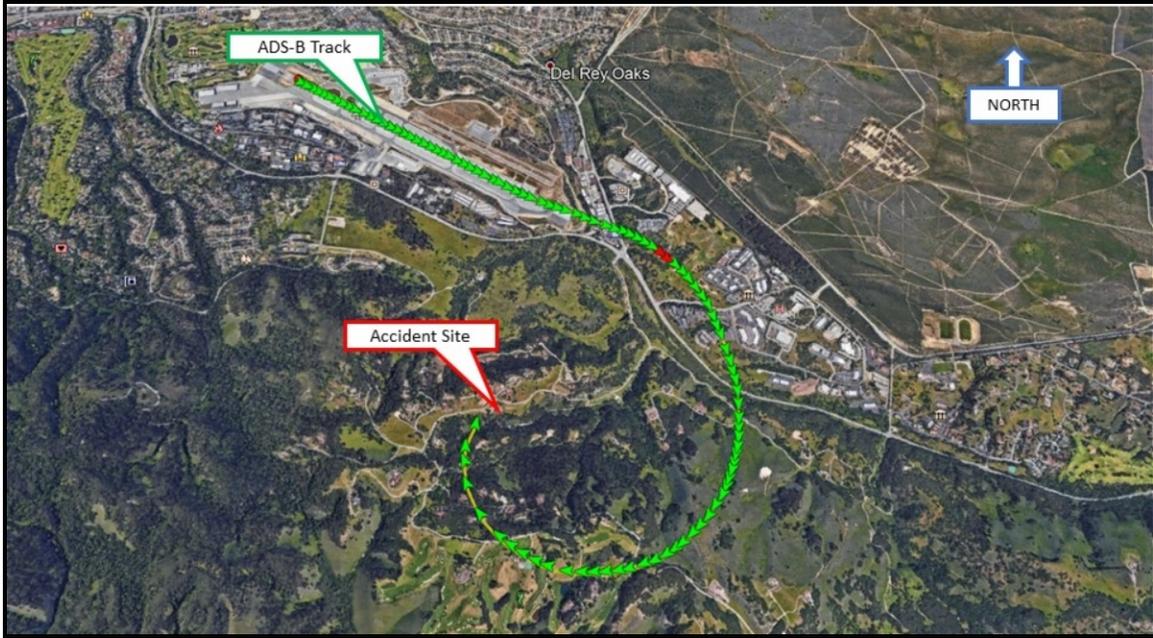
The airplane's climbing right turn occurred shortly after the airplane entered IMC while the pilot was acknowledging a frequency change, contacting the next controller, and acknowledging the heading instruction. Track data show that as the right-hand turn continued, the airplane began descending, which was not consistent with its clearance.

Recorded automatic dependent surveillance-broadcast (ADS-B) data provided by the Federal Aviation Administration (FAA) showed that the airplane departed from runway 10R at 1738:44 and ascended to 1,075 ft msl before a right turn was initiated. The data showed that at 1740:14, the airplane continued to ascend in a right turn and reached an altitude of 2,000 ft msl before a descent began. The airplane continued in a right descending turn until ADS-B contact was lost at 1740:38, at an altitude of 775 ft msl, about 520 ft southwest of the accident site as seen in figure 1.

Figure 1: View of airplane ADS-B track.

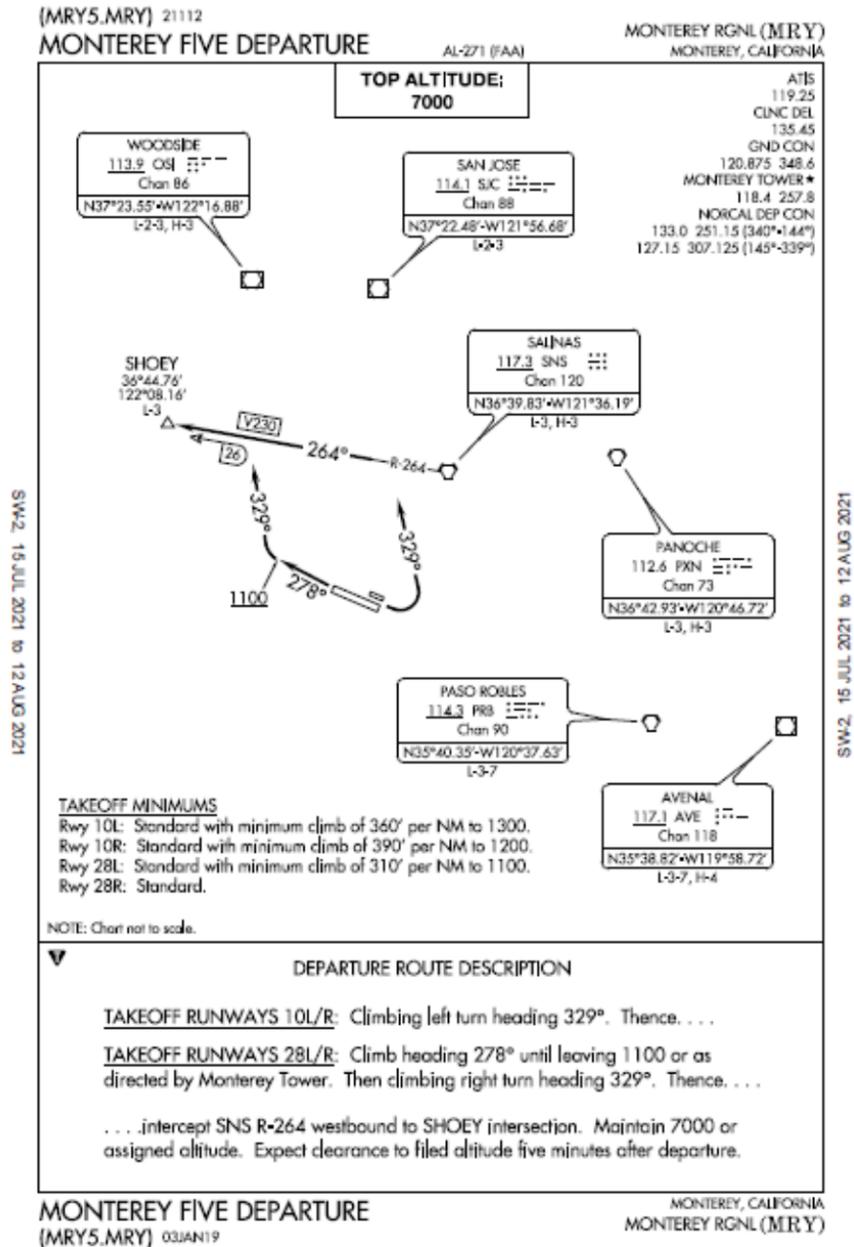
The Monterey Regional Airport is a public airport operating under class-Delta airspace. The airport features multiple runways. Runway 10R, is charted with two IFR departure procedures (both requiring a climbing left turn after takeoff), elevation is 158 ft and runway dimensions are 7,175 ft x 150 ft.

Figure 2: View of the Monterey Five Departure procedure.

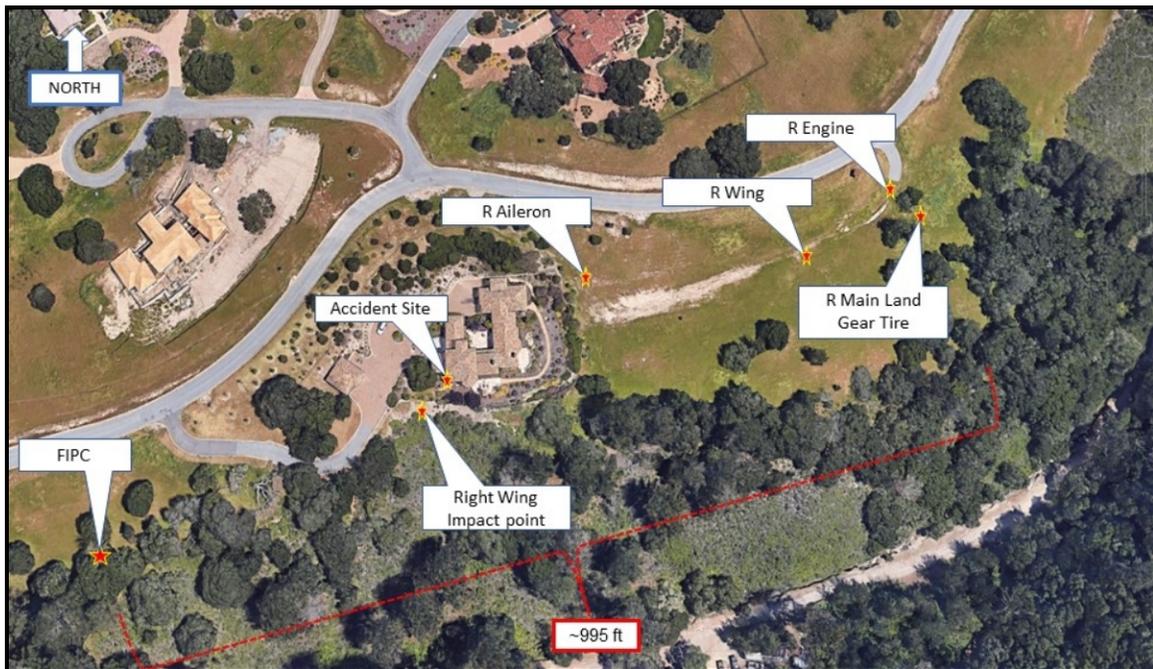
Examination of the accident site revealed that the airplane impacted trees about 1 mile south of the departure end of runway 10R. The first identifiable point of contact (FIPC) was a 50 to 75 ft tall tree that had damaged limbs near the top of the tree. The debris path was oriented on a heading of about 067° and was about 995 ft in length from the FIPC, as seen in figure 3. The main wreckage was located about 405 ft from the FIPC. Various portions of aluminum wing skin, right wing, flap, aileron, engine, propeller blades, and propeller hub were observed throughout the debris path. Additionally, several trees were damaged throughout the debris path. The fuselage came to rest upright against a residential structure at an elevation of 447 ft msl.

Figure 3: View of accident site diagram.
